# TREGEIRIOG HOUSE, LLANGOVAN, MONMOUTHSHIRE NP25 4BU

**DESIGN AND ACCESS STATEMENT &  
HERITAGE STATEMENT  
FOR RESTORATION AND ALTERATION WORKS**

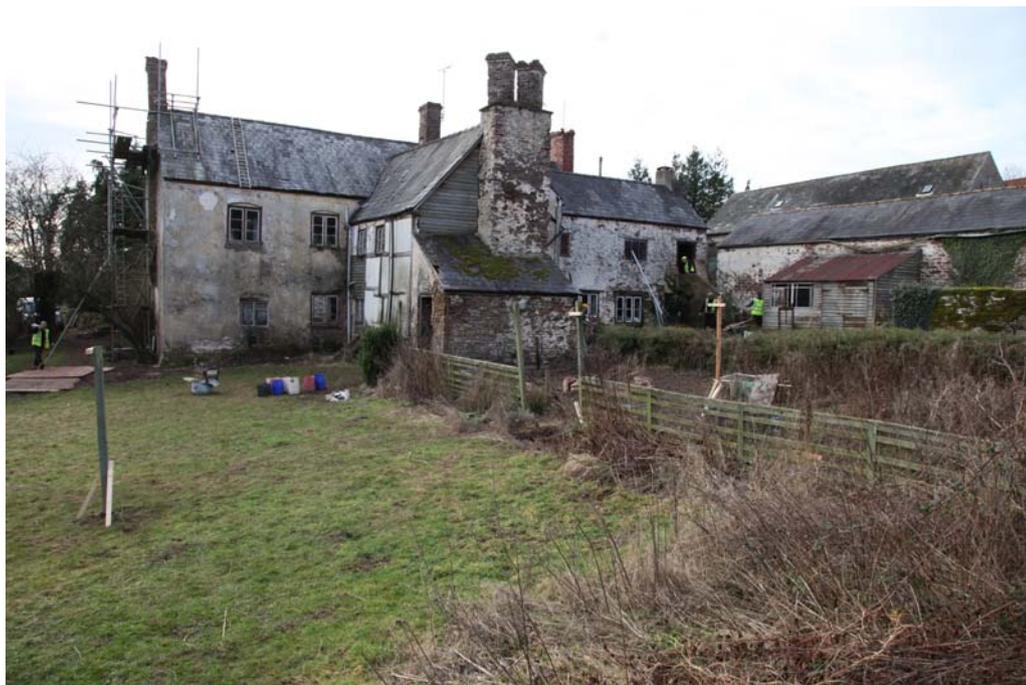
**Rear of Tregeiriog House showing timber north wing and west parallel wing (right)**

The house consists of a main two storey stone range with extensive cellars and attic rooms under a welsh slate roof; a parallel stone range to the north west; a two storey plus attic timber-framed wing to the north. The whole sits in the southwest corner of a plot of just over two acres (0.8ha). There is a range of brick built pig styes plus a timber lean-to shed just to the north of the house and a small brick shed to the east but otherwise the plot is laid to garden with mature trees and hedging.

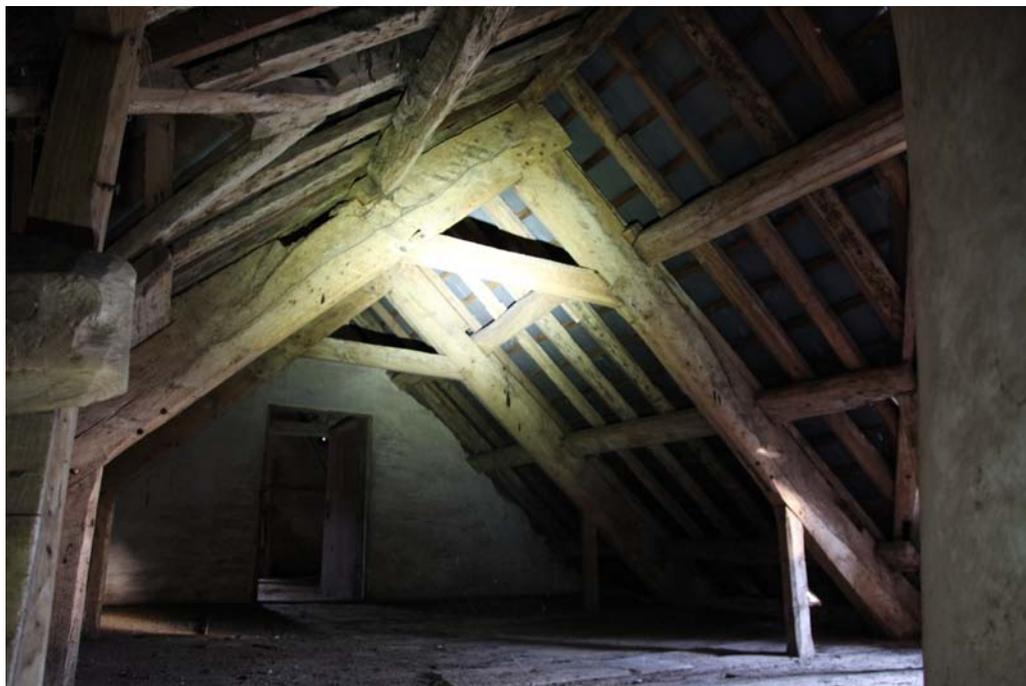
**East end roof truss showing empty mortices with peg holes for removed raking struts**

There is evidence in the attic that the roof trusses have been altered though no evidence that the roof height and profile has changed. There are mortice holes for raking struts in the principle rafters with inserted vertical posts acting as props onto the tie beam instead (See photograph above). This

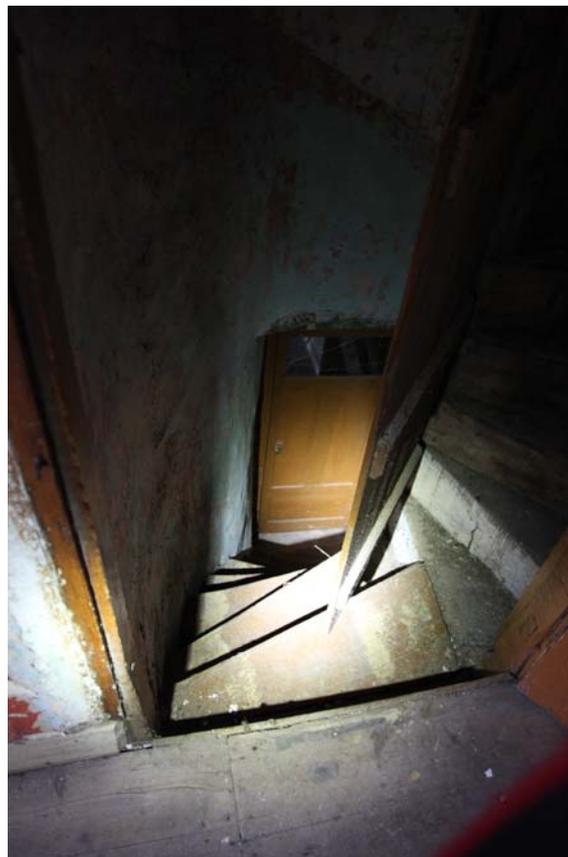
**Straightened "spiral" stair from ground to first floor with doors top and bottom plus spiral stair from first to second floor behind a further door.**

With the addition to the west the original location of the front entrance door, on the west gable, was moved to the south elevation with a resultant baffle entry layout. To the north side of the original chimney, the staircase was probably reorientated at this time so that it came down into the new, more prestigious room. This would account for the unusual line of the staircase (See photograph below).

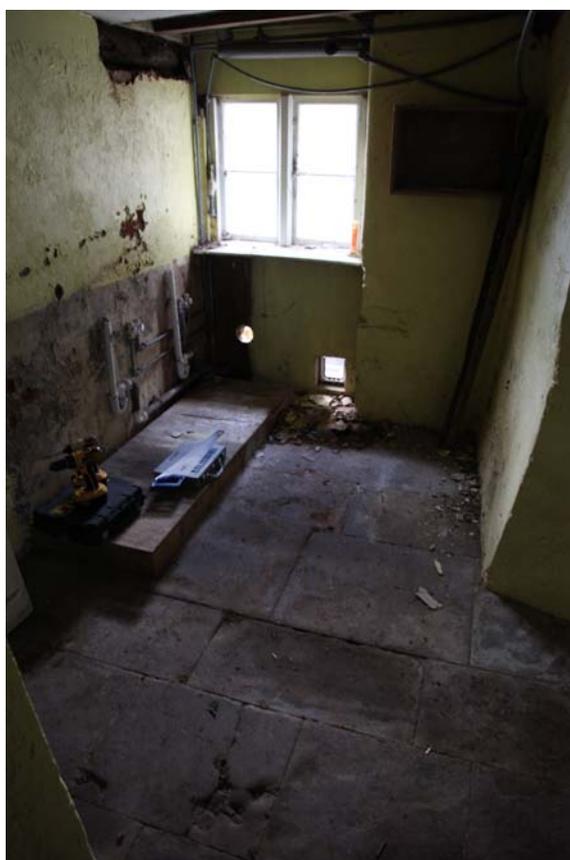
**Timber frame external wall incorporating remnant of stone wall (right of window) projecting out from front range.**

The third phase of major building work occurred in the later 17<sup>th</sup> century with the addition of the timber-framed, two-storey north wing consisting of a bay and a half plus a large stone chimney with diagonally set stacks at the north end. This east wall of the extension conflicts with a blocked up window in the rear wall of the front range and therefore must be of a later date, contrary to the 1990s application report mentioned above. However the timber frame does show some anomalies: there is a section of storey-height stone wall which projects from the front range and round which the timber frame has been constructed (see photograph below); the height of the plinth on the east and west walls is significantly different with the sole plate on the west wall almost sitting at mid-rail height and that of the east wall being at ground floor level. Though the significance of these items has not yet been explained it may suggest that there was an earlier stone building on the footprint of the timber-frame building.

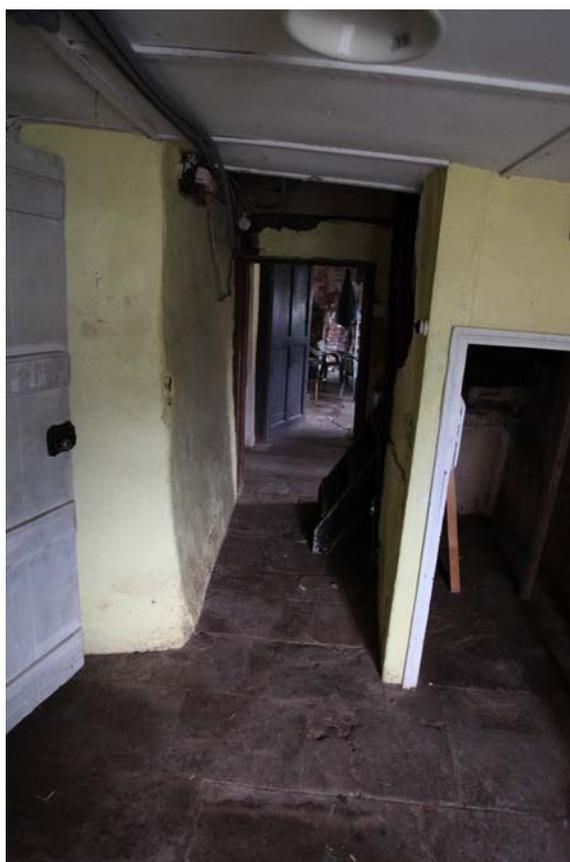
**Base of mast staircase in inner hall with cracks providing evidence of original line of stairs in battered front range wall. Door to left provides access to drawing room and front range.**

The half bay in the timber north wing sits between the front range and the north wing rooms forming a generous lobby at each level. The doorway giving access into the original part of the house from this lobby is particularly decorative in its architrave and door detailing, possibly denoting its use by important members of the household or visitors rather than purely servant access. This is also the location of the mast stair that rises from ground to first to attic level with a landing at each level including the attic. The lowest three steps are clearly a later alteration as they are straight rather than winding and they are set at a much steeper pitch due to the available space in the hallway and the need to access the doorway (see photograph below) . However it is possible to see the line of the original stairs in the rear wall of the front range and this confirms that the staircase original continued to spiral down to ground floor level round the central mast.

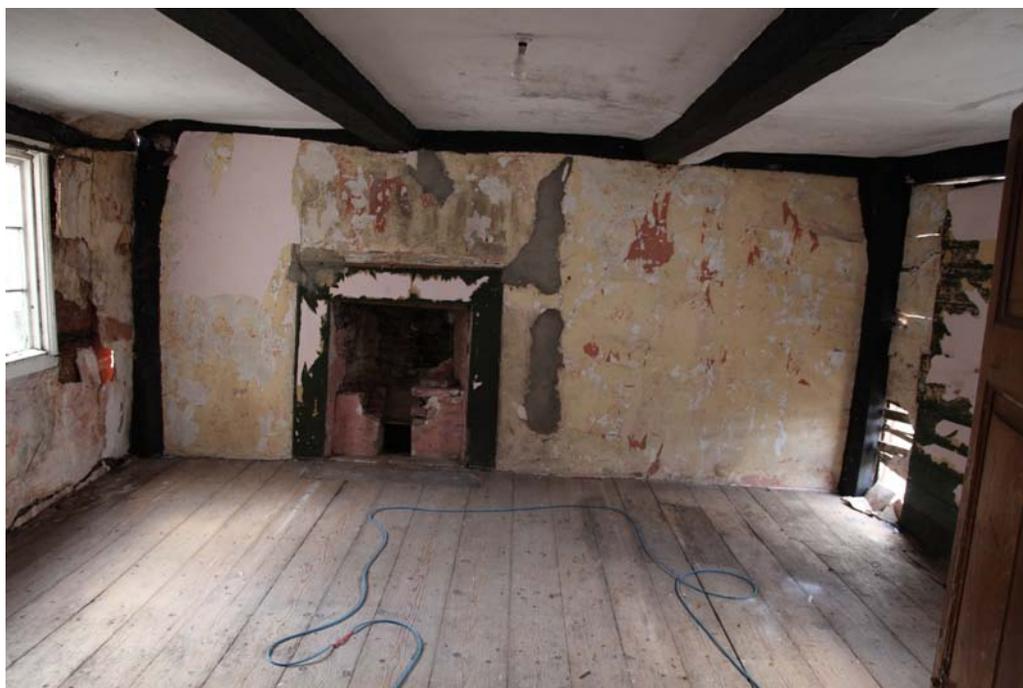
**First floor bedroom showing hob grate fireplace and reeded moulding to ceiling**

The mast stair gave access to a luxury bedroom on the first floor with reeded moulding to the three sections of the ceiling and a fireplace that indicates the use of a hob grate, though this is no longer present (see photograph below). The attic room was separated from the landing with a partition utilizing the roof truss. Though there is now a dormer window to the west, and evidence of another to the east, these were only inserted after the west roof pitch was increased in height, possibly in the 19<sup>th</sup> century though possibly earlier. It is therefore not clear whether the attic spaces had any natural light when originally constructed.

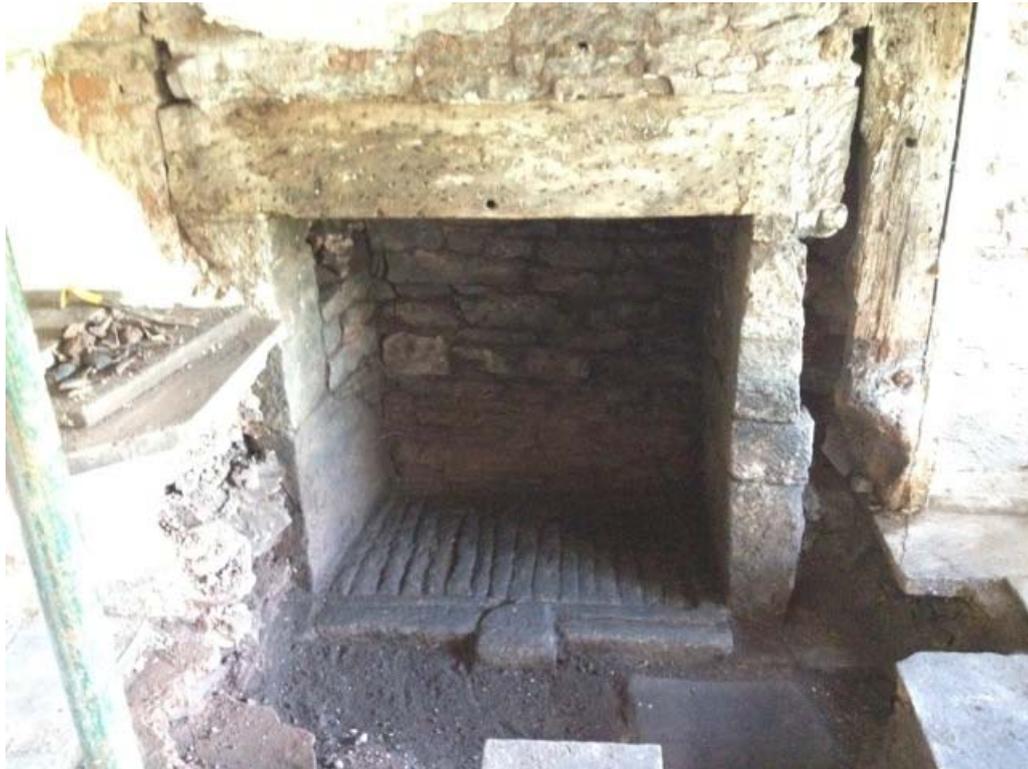
**Dairy fireplace showing cobbled hearth and difference in floor levels – stone shelf to left.**

The ground floor room has been the subject of change both in volume and use. The dairy as it has been known, has a particularly low ceiling height, though the floor level is consistent with the adjacent rooms. The reason for this becomes clear after the discovery, behind some decayed wall plaster, of a hidden fireplace in the north wall. This fireplace is of roughly the same dimensions as the first floor fireplace and has a hearth at a level about 300mm lower than the existing ground floor level. It was clearly constructed as an open fire with a cobbled hearth and a simple timber bressumer beam (See photograph below).

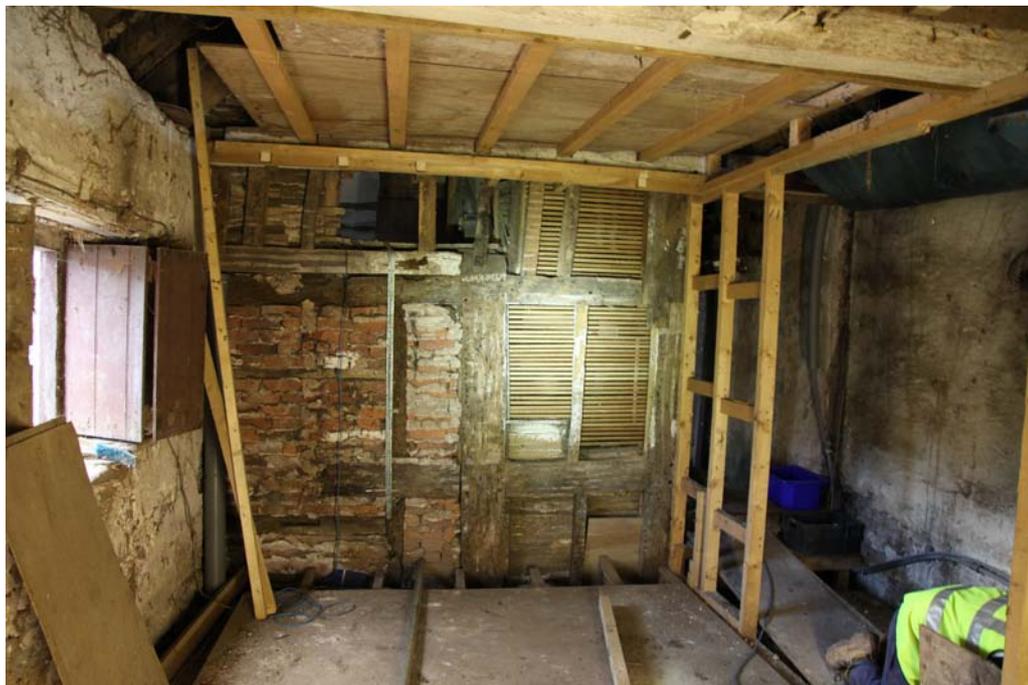
**Separating wall between parallel and north ranges showing increase in height of timber-framed wall and recent access from mast stair to the right. Valley gutter runs along wall to right.**

The fourth major addition to Tregeiriog House was the rear parallel range to the west of the north wing. This was added after the west roof pitch had been raised on the timber frame wing, as evidenced by the wall separating the two structures (see photograph below). This was clearly built as a service wing with the kitchen on the ground floor, a granary to the first floor and attic rooms.

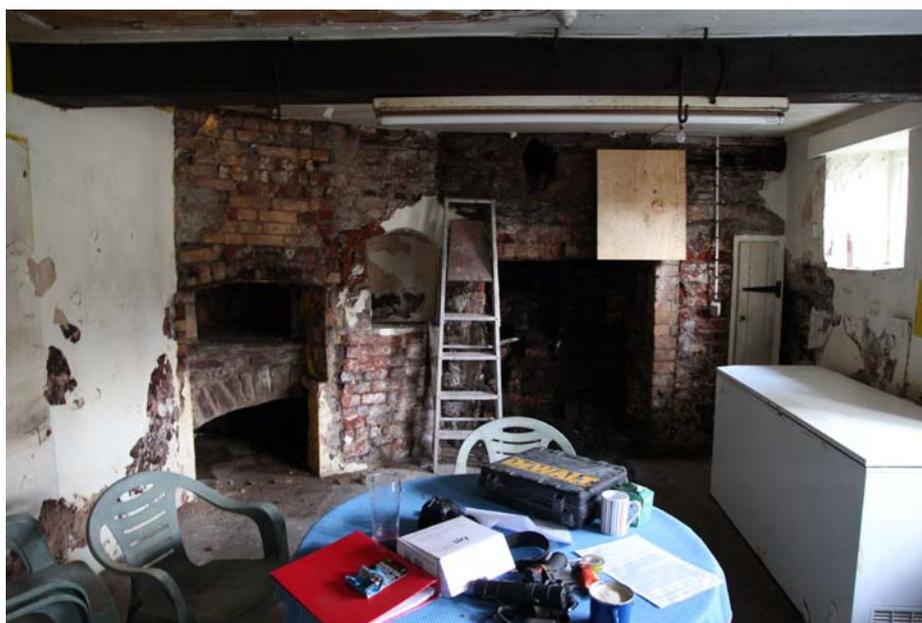
**Kitchen showing several layers of fireplaces and ovens**

The kitchen has several layers of fireplaces and ovens the history of which has not so far been unpicked (see photograph below). The large chimney may have two flues within though it latterly only had one and even this has been truncated and fallen out of service. If the chimney originally had two flues they may have served both the ground and first floors or provided for two fires at ground floor level.

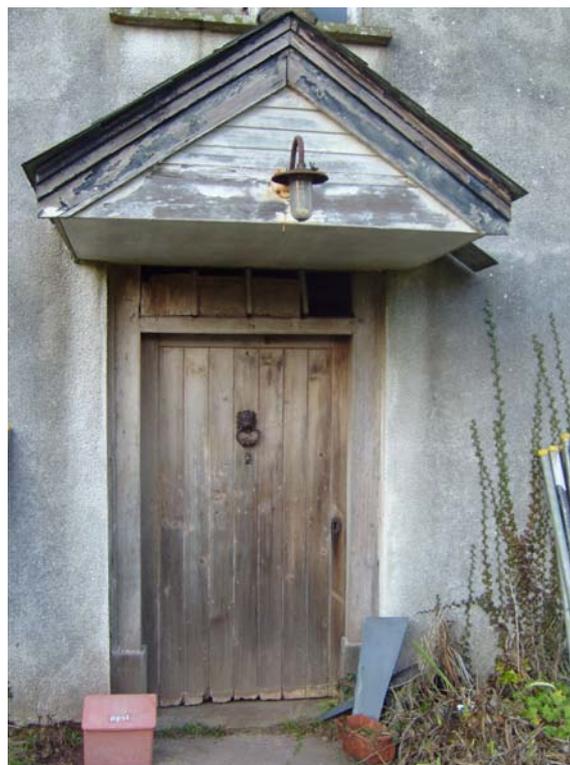
**Substantial boarded entrance door showing paneled "fanlight" part obscured by later canopy porch.**

Many of the doors belong to this 1758 phase and exhibit raised and fielded paneling with paint effect wood graining mimicking quartered veneers. Other doors are of 17<sup>th</sup> century origin though the front door with its paneled "fanlight" may be of 16<sup>th</sup> century date having been moved from its original location on the first west gable (see photograph below).
